# Summary Report

Seminole Expressway (SR 417) Resurfacing and Safety Improvements  
Financial Project Nos. 429023-1-52-01 & 429023-3-52-01  
Contract E8N21

This project consists of Milling and Resurfacing of SR 417 from US 17-92 to I-4 (MP 50-55) with median guardrail installation and drainage improvements along Mainline. Reconstruction of Ramp D (17-92 NB off ramp)

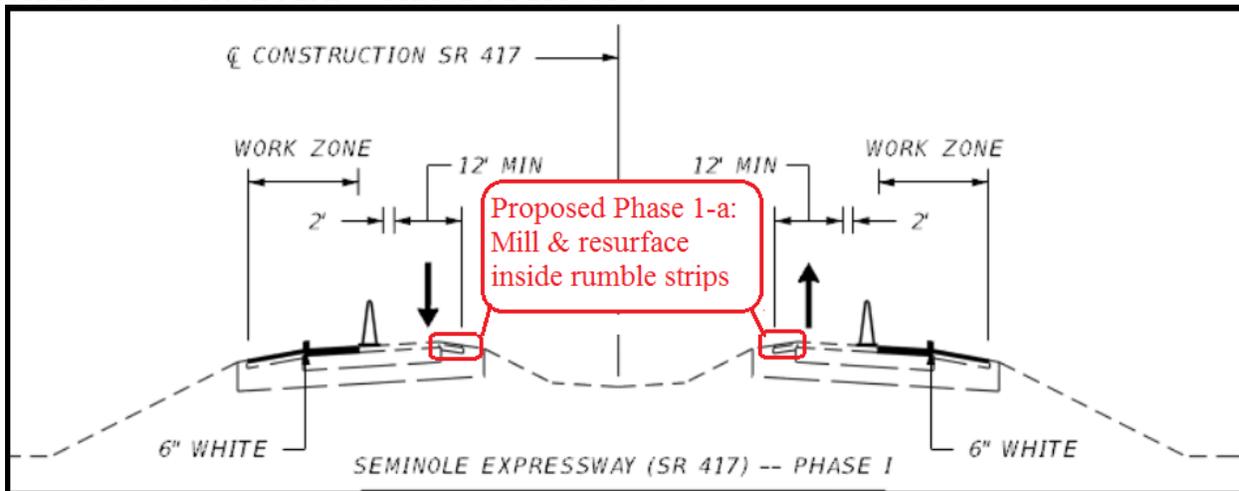
TRAFFIC CONTROL PLAN – PHASE 1 DEPICTION:

The plans called for milling up inside shoulder rumble strips and replacing with asphalt, as well as outside shoulders through super elevated sections. The purpose was to ensure a smooth shoulder surface was maintained for any vehicles that may partially shift out of the travel lane.

The issue this presents is an entire TCP phase to prevent a temporary and unlikely smoothness issue,

TEMPORARY TCP NOTE (sheet 54):

PHASE 1-A (NOT SHOWN)  
UTILIZE LANE CLOSURES PER INDEX 670 TO MILL AND RESURFACE THE INSIDE SHOULDER (TO REMOVE EXISTING RUMBLE STRIPS) (OUTSIDE SHOULDER THROUGH SUPER ELEVATED SECTIONS)

It was agreed to simply pave over the rumble strips, without milling them out. This approach was agreed upon with concurrence from the EOR and Turnpike Bituminous Engineer. Pros: less equipment required, no millings to sweep and dispose of. Paving over removes the drop off, providing a smoother surface for the vehicles to ride on. Credit to the project was realized (\$8,071.84).

It is recommended that for instances when the Traffic Control plans call for traffic to be temporarily shifted to the shoulder, for short periods and lower speeds, to pave over the rumble strips instead of milling and paving. The low traffic volumes should not cause the underlying rumble strips to reflect in such a short period of time.

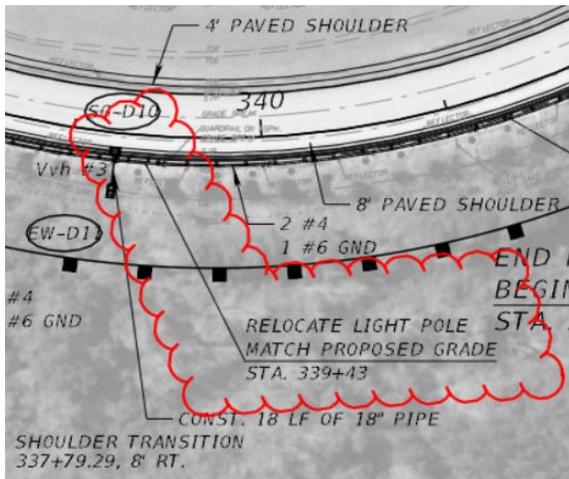
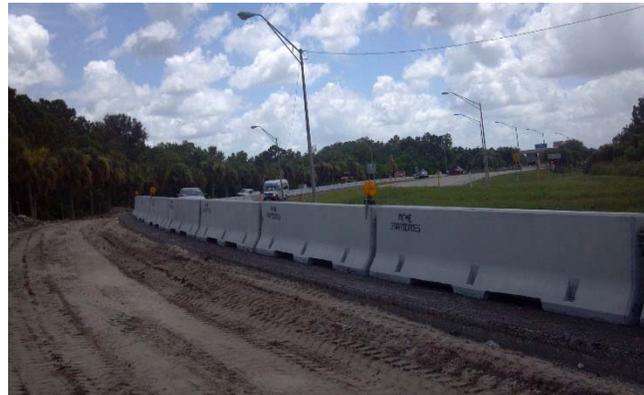
No temporary lighting or means of payment was identified in the plans, during the construction of ramp D lanes and side slopes. The plans only called for existing lighting was to be relocated.

It was determined that temporary lighting would be required during the ramp's 1<sup>st</sup> construction phase

A change order was processed to pay for the construction of the temporary lighting. New light pole bases were ordered to replace the existing.

On any project with lighting pay-items, it is recommended that the designer evaluate the need for temporary lighting, identify the requirements, and provide the necessary notes, specs, and pay items to allow the contractor to properly bid.

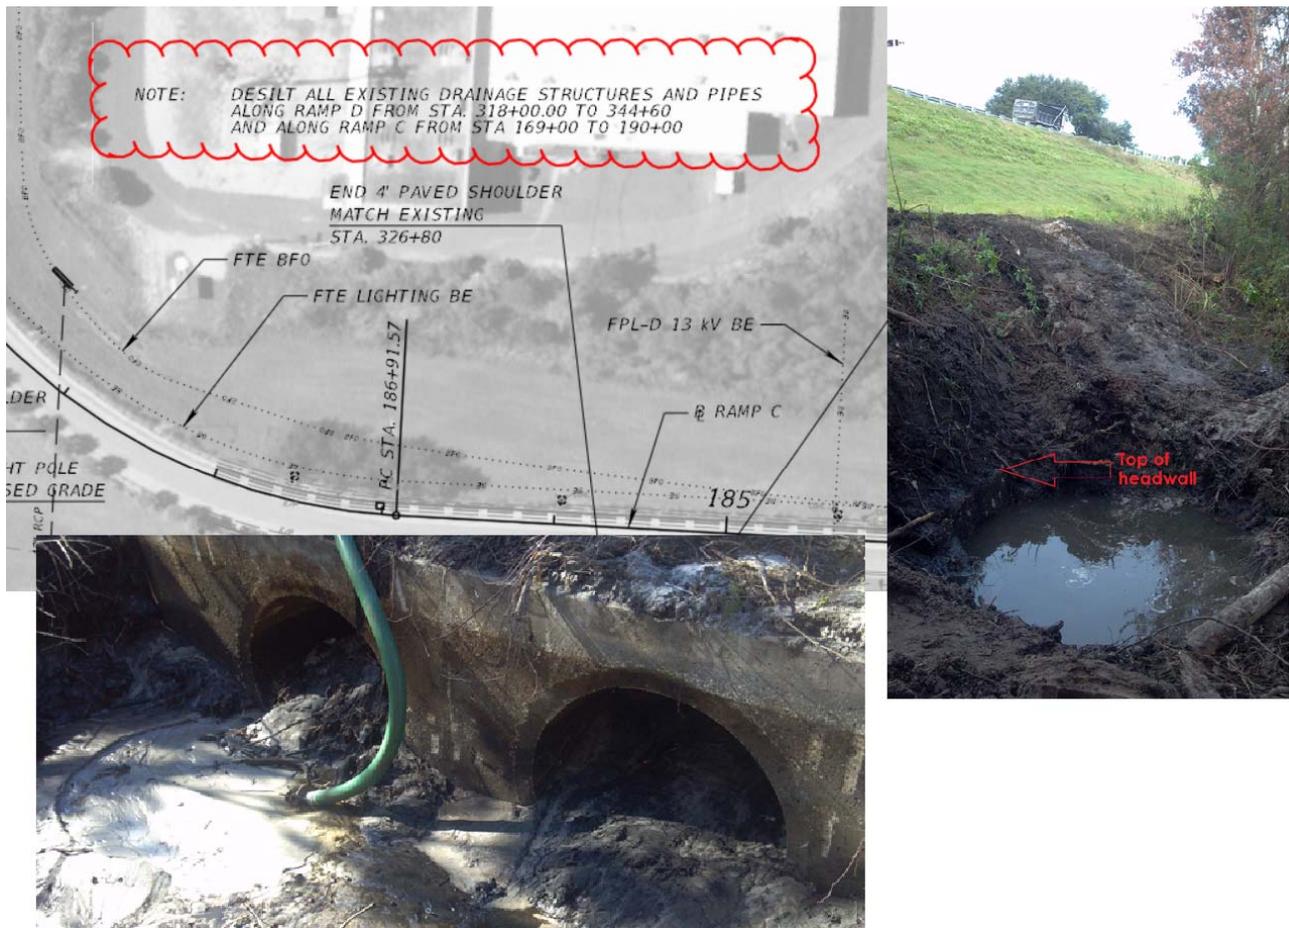
Access to desilt Ramp C & D's pipes was a challenge, as most of the headwalls were submerged by heavy overgrowth of vegetation. The plans provided pay items for the desilting, but did not consider the extensive clearing needed to access these structures.

In addition, a larger clearing effort of the surrounding outfall/swale areas was necessary to ensure the long term clearance of the pipes. One extreme case required ~ 7' of excavation to uncover the pipe. Functionality of the pipe and nearby swales was stifled by years of overgrowth. Simply clearing in front of the headwall openings would not allow water conveyance to or from the pipes.

The desilting effort was complicated by concrete block obstructions found inside the pipe openings (believed to be riprap or spill-way pads that were pushed into the pipes in historic clearing efforts). Access to remove these obstructions was arduous, given their mass, poor visibility in submerged murky pipes, and encasement within dense muck. Consequently, plugging these pipes was not possible, and desilting was abandoned for those circumstances.

A partnering effort, between Turnpike's Maintenance & Construction departments, was made to clear immediately in front of the headwalls and desilt where possible. TPK Maintenance performed the clearing with an excavator, and the Construction Contractor attempted to plug the pipes for desilting.

- 1.) Designer and Department confirm the conditions of any pipes to be desilted, and convey any necessary efforts needed for the benefit of the bid. (i.e. clearing limits).
- 2.) Modify Standard Specification 430-10 to include all clearing required for access, the use of coffer dams, dikes, or other measures to dewater the pipe. Section 430-10 is currently stated as the following, which does not address any clearing efforts:
